MISCELLANEOUS PAPER S-73-39

# CONDITION SURVEY, CARSWELL AIR FORCE BASE, TEXAS

2. The purpose of this report is to present the results of a condition survey performed at Carswell Air Force Base (CAFB), Texas, during 16-19 December 1972. The following two major areas of interest were considered in this survey:

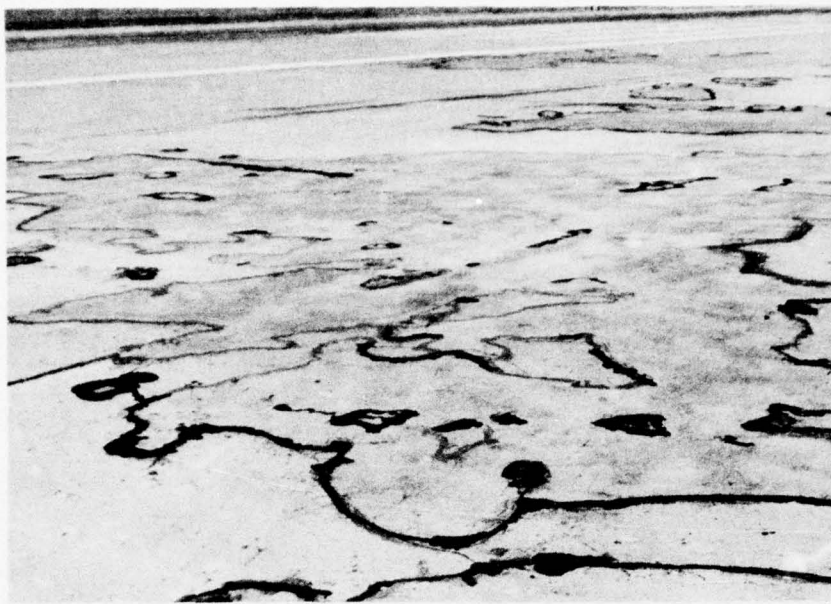
Photo 1. Epoxy patches near south end of runway

14. All the 15-, 16-, and 18-in. portland cement concrete (PCC) pavements, features R1A, R2B, R5C, R6C, R7C, R8B, R9A, and R10D, were in excellent structural condition, with only 18 major defects noted. Photo 1 shows epoxy patches used to correct surface irregularities in several slabs near the south end of the runway. These irregularities resulted from an aircraft having burned at this location. Features R4C and R3C, which had been overlaid with asphaltic-concrete (AC) pavement, were in good condition. At the time of the overlay, a french drain was installed along the west side of the runway. The drain seems to have cured the problem of slab settlement. Photos 2 and 3 show the condition of the AC pavement on the runway.
